# Pavilion at the Novartis Campus

**EBP has completed the planning for a ground-level park and a multifunctional basement area as part of a project known as “The Square” at the Novartis Campus in Basel. The park includes a 30-by-8-meter glass pavilion and an elegant stairway roof atop the basement.**

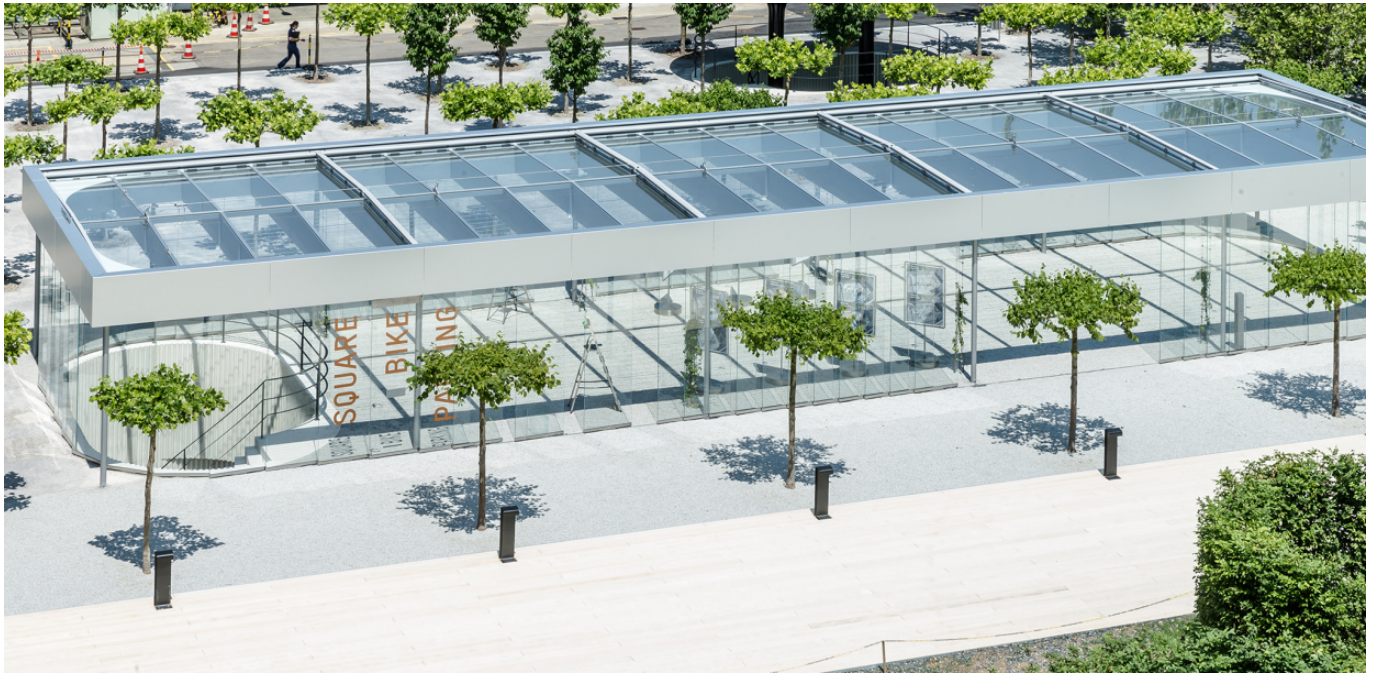
In addition to offering a pleasant place for people to linger and an appealing venue for events, the pavilion serves as a roof for the main stairway link to the basement where commuters can park their bicycles.

The slender and virtually inconspicuous load-bearing structure for the glass pavilion is a lightweight steel frame. Although unheated, the pavilion serves as a shelter against the elements. Outfitted with scaled, sliding glass walls, the pavilion can be opened at each of its long ends, a feature that was worked out independently by EBP according to design specifications provided by Good Form Studio. This work included a determination of a scaling angle that would enable the sliding glass walls to slide together and thereby allow the pavilion to be opened as widely as possible. The same angle needed to be curved by a certain radius at the rounded corners without enlarging the pavilion's exterior dimensions. It was also essential to ensure that the appearance of the two access doors, which include an escape-route function, would resemble that of the sliding glass walls as much as possible. The development process resulted in a simple, solid construction.

Pavilion overheating is prevented by the open joint between the glass walls and the roof that allows the air to circulate continuously. A retractable solar shade can also be extended to reduce direct sunlight and glare. The mechanism for the shade was integrated into the edge of the circumferential roof while the utility lines (electric and water) were integrated into the steel frame in a manner that renders them invisible while also ensuring their immediate accessibility.

The glass for the roof was manufactured with an interlayer of SentryGlas® that has an especially high UV-permeability rate so as not to hinder the growth of the vines inside the pavilion.

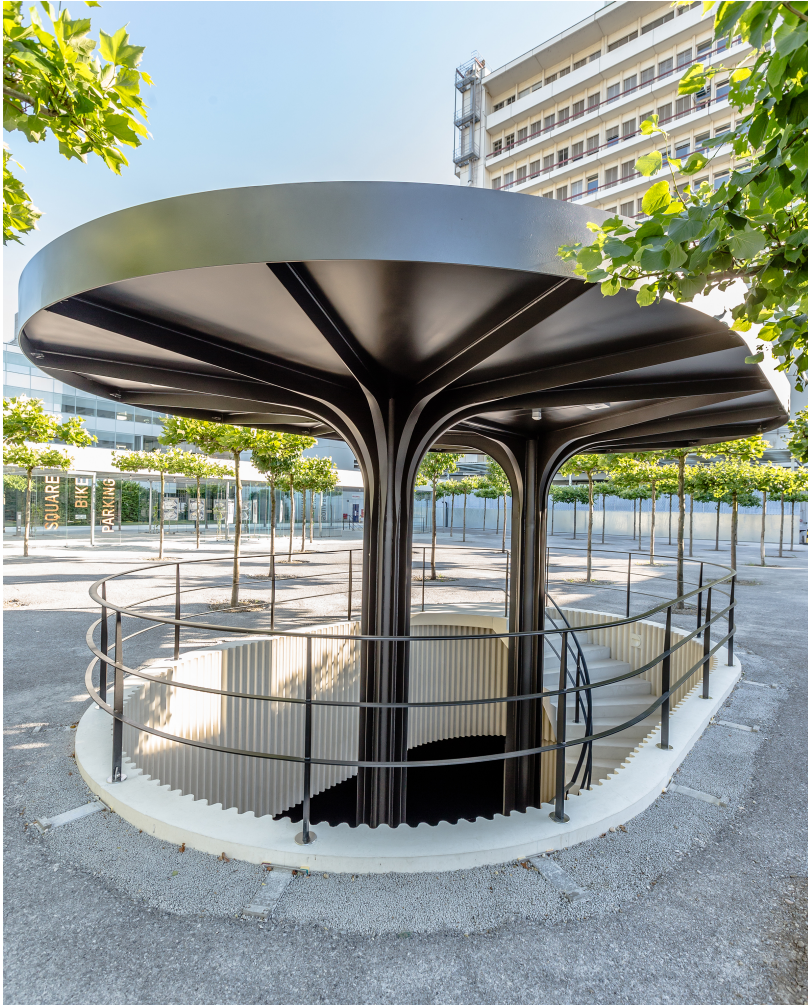
Another functionally and aesthetically important element in the park is the stairway on the park's northern end. The steel roof appears to grow out of the underground level through the open space in the spiral staircase. The roof is comprised of two columns and an oval crown. The ribs welded to the columns arch outward just below the crown to provide a load-bearing structure. Here, too, all of the electrical and water lines are integrated into the steel construction for maintenance-free operation. Back-ventilated, titanium-zinc sheets arranged in a star pattern serve as the roof's skin.
